**Final Report**

**Feasibility Study  
on the  
Restoration of Bixler Lake**

**Kendallville Park and Recreation Department  
211 Iddings Street  
Kendallville, Indiana 46755**

**International Science & Technology, Inc.  
100 Carpenter Drive, Suite 206  
Sterling, Virginia 22170**

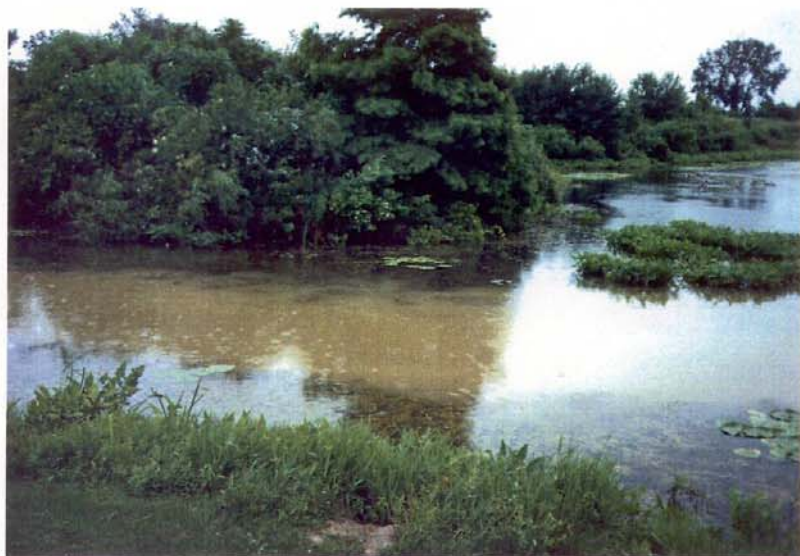
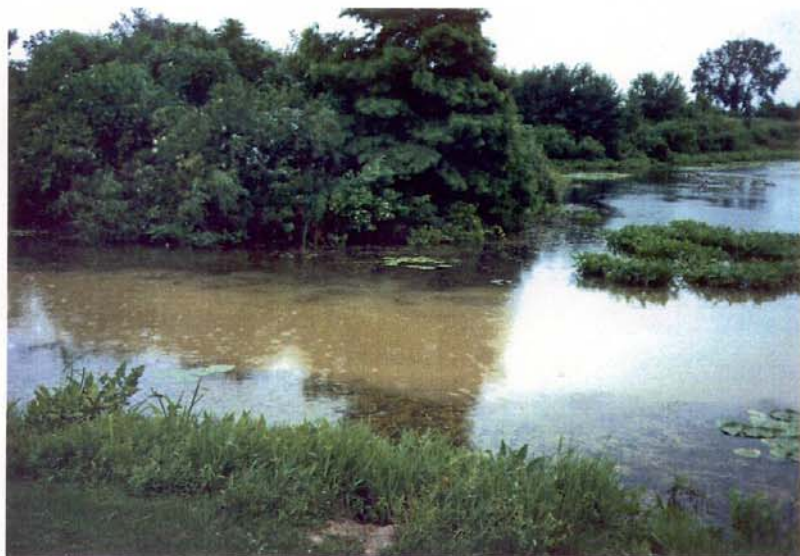
**PHOTO 3-1.        Sediment laden water entering Bixler Lake near the ditch/canal on the northern shore.**

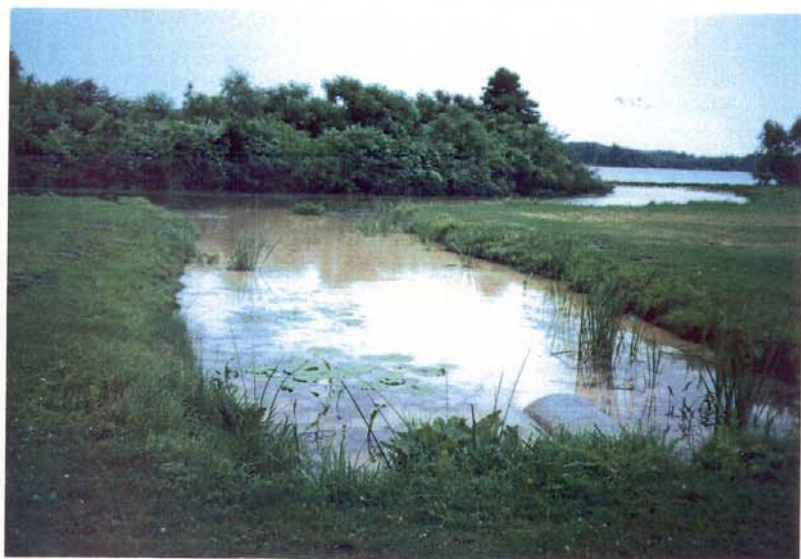
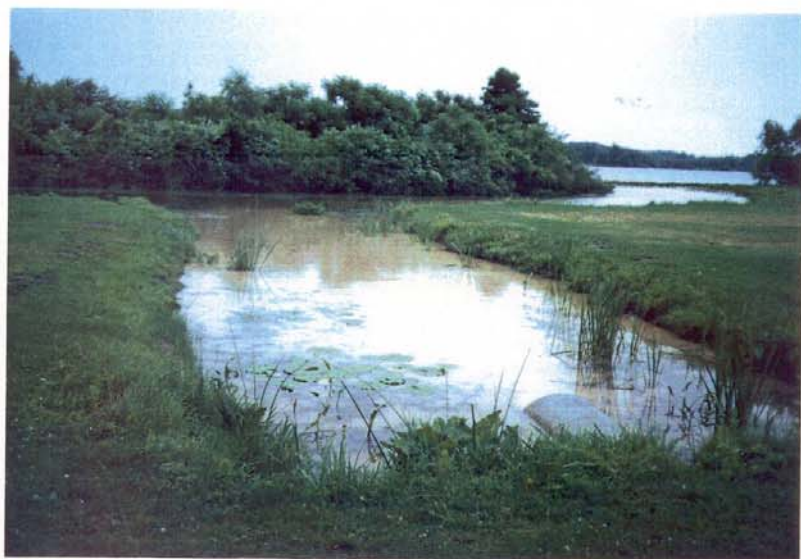
**PHOTO 3-2.        Sediment laden water from the construction site entering the ditch/canal on the northern shore of Bixler Lake.**

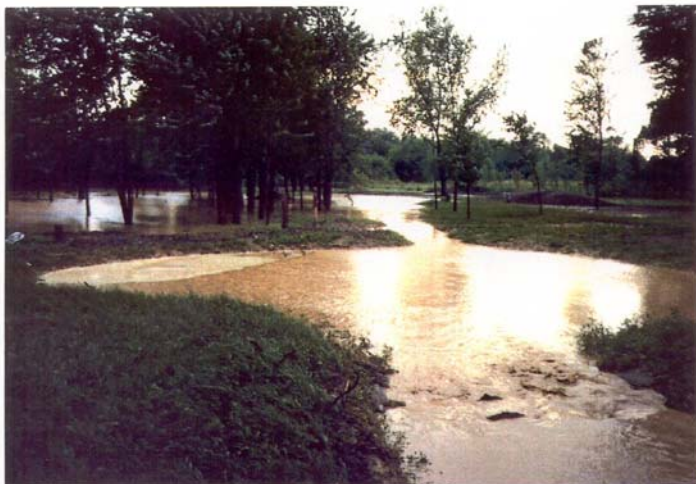
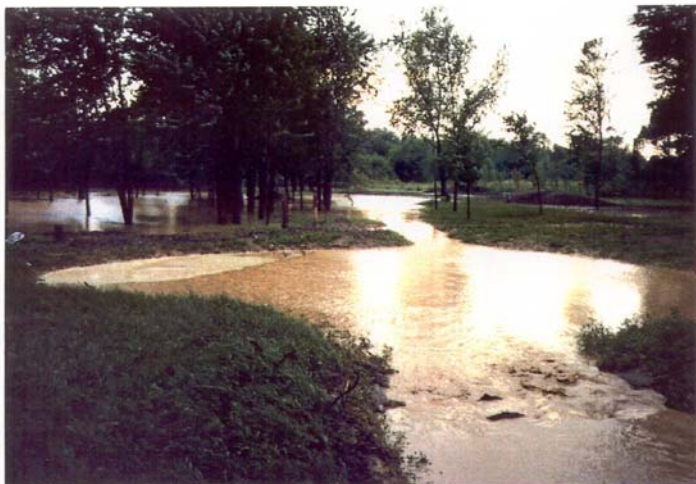
**PHOTO 3-3.** Flooded woodland that receives run-off directly from the construction site on the north side of the railroad tracks.

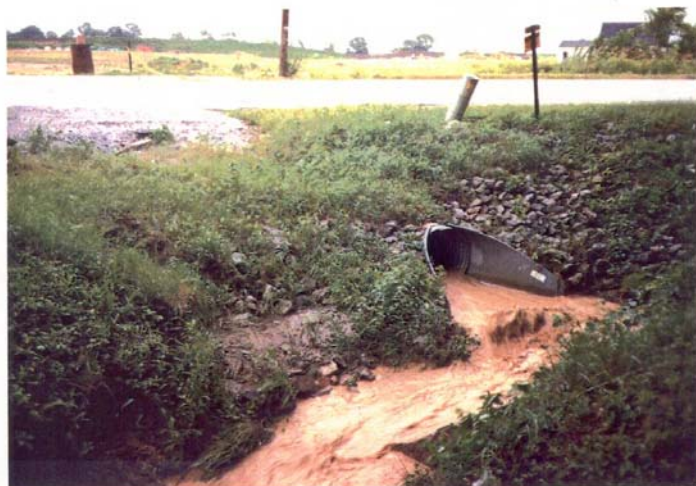
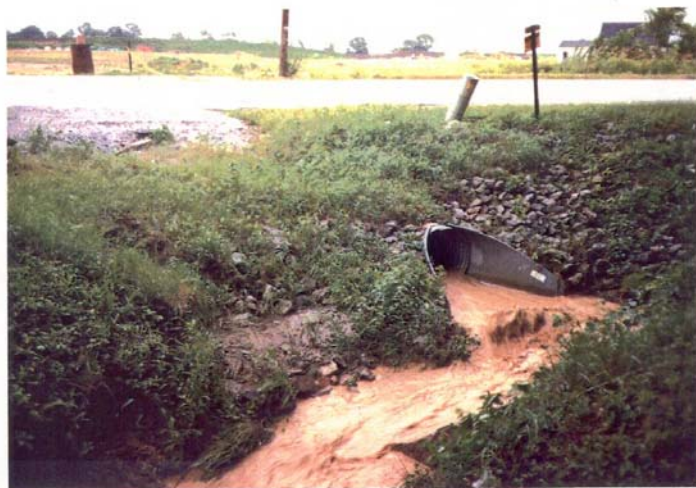
**PHOTO 3-4.** Culvert outlet draining the construction site.

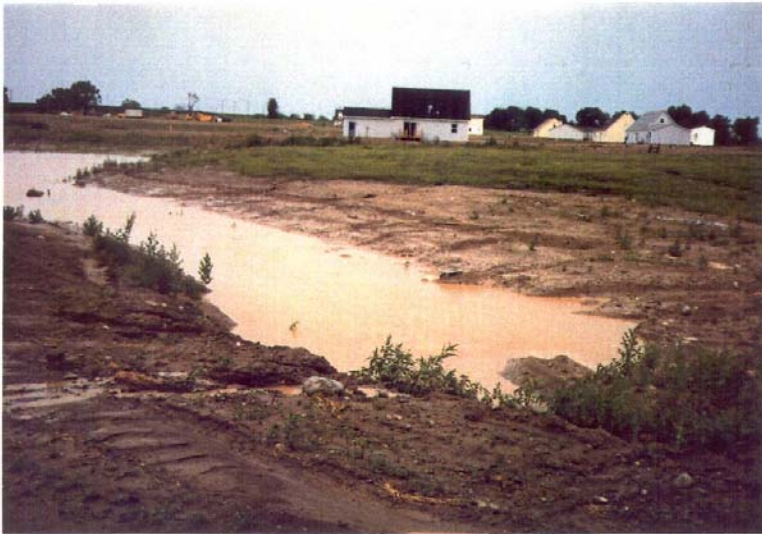
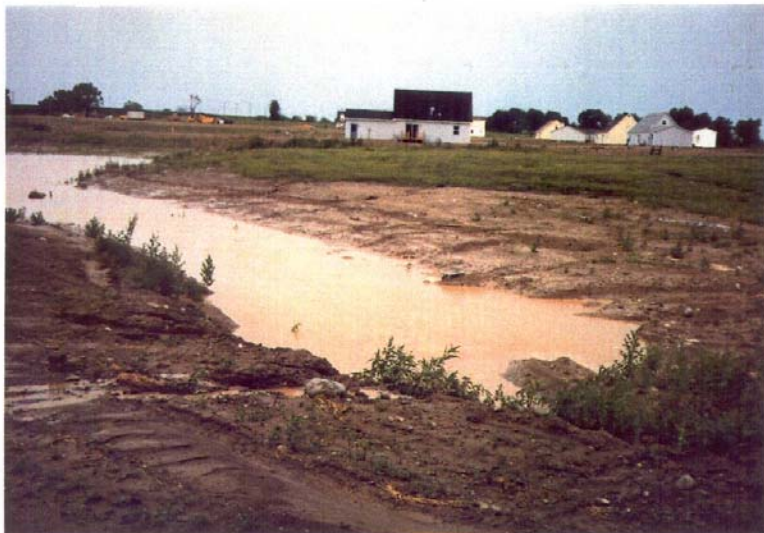
**PHOTO 3-5.** Detention basin and eroded areas on the southern edge of the construction site.
